NSS Exposed for 1,200 Hours

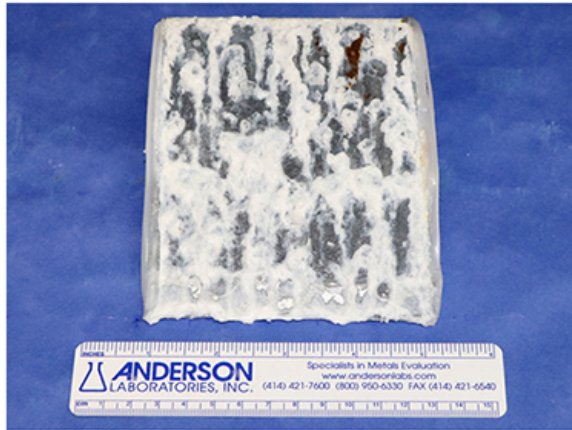
G235
Overbend (Tool Defects)

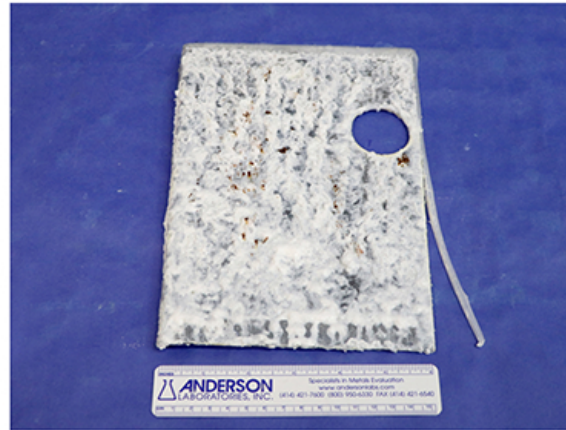
G235
"Flat" w.Perf.

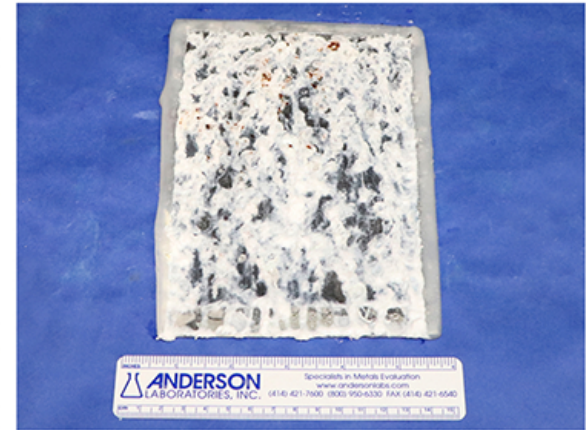
G235
"Flat" Field

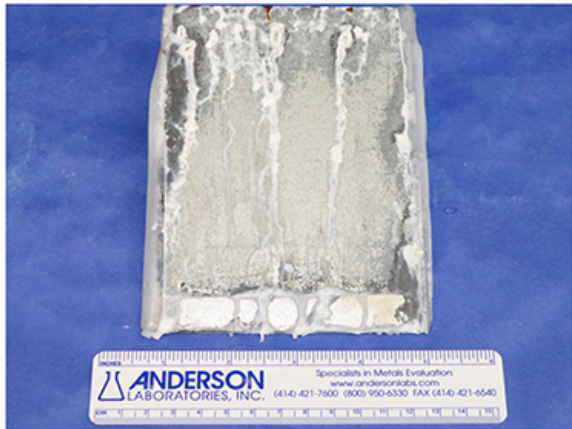
HDG G40 + CG-AG
Overbend (Tool Defects)

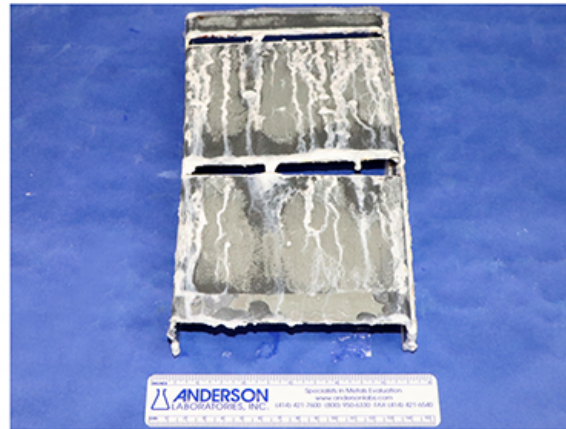
HDG G40 + CG-AG
Expanded Sidewall - Edge Test

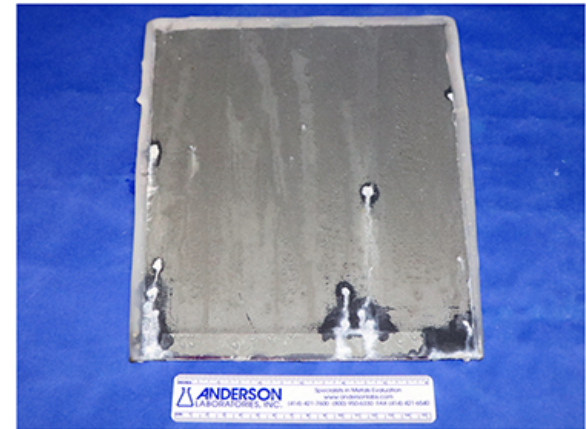
HDG G40 + CG-AG
"Flat" Field
